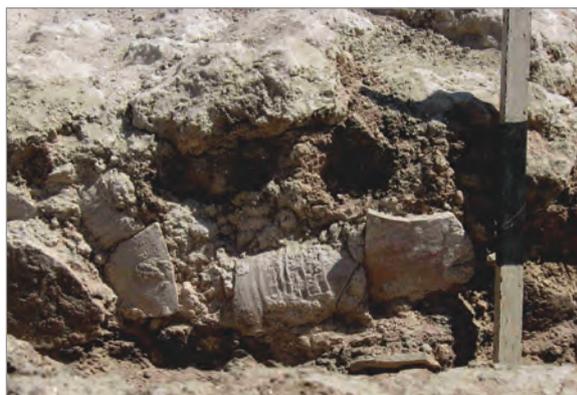
Figure 13. Area B: pottery and plaster in the aqueduct interior.

In this area many pottery fragments were found incorporated with the plaster inside the aqueduct (Fig. 13).

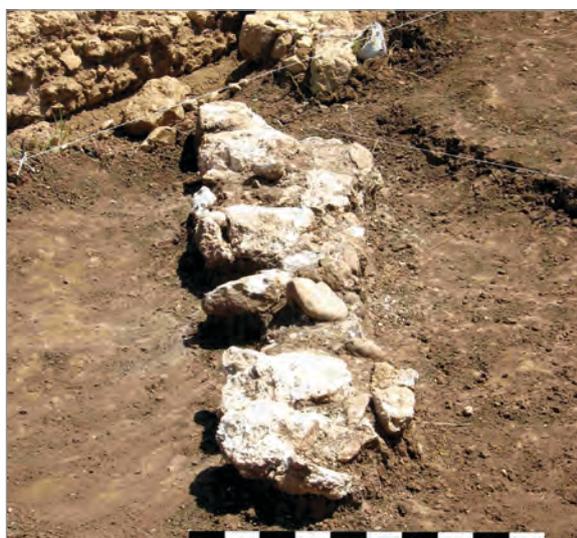
Figure 14. Area C, facing northeast: W101 with the aqueduct excavated by the Israel Antiquities Authority in the background.

In the IAA's test excavation a 0.6m-wide single-course wall was found projecting southwestward from the southern wall of the aqueduct at an angle of 42°. We excavated the wall and its immediate surroundings in order to expose any continuation or possible associated features. A further 3.4m section was found (Fig. 14). The wall survived to a single course, was 6.85m long and 0.6m wide. A 1.3m-long section of the feature had been damaged.

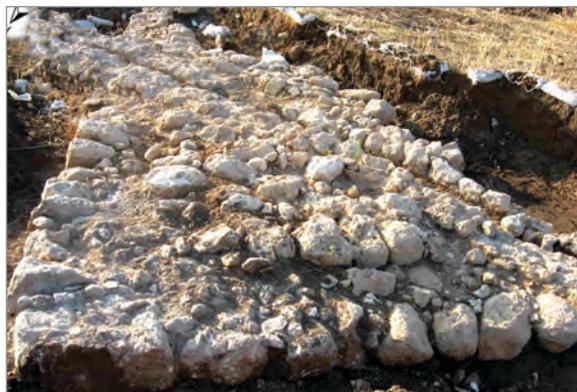
Figure 15. Area C, facing southeast: the stone surface.

During the IAA test excavation a level area of stones was found projecting from the northern wall of the aqueduct. An area was opened in order to expose more of this feature (Fig. 15). We uncovered a stone surface which was triangular shape in plan, abutted the aqueduct's north wall and was constructed from a single layer of medium- and large-sized fieldstones. The entire area of this triangular feature was 9m². The lines of the triangle's edges also extended southeastward (Wall W005) and southwestward (Wall W101) on the other (south) side of the aqueduct (see Fig. 3).

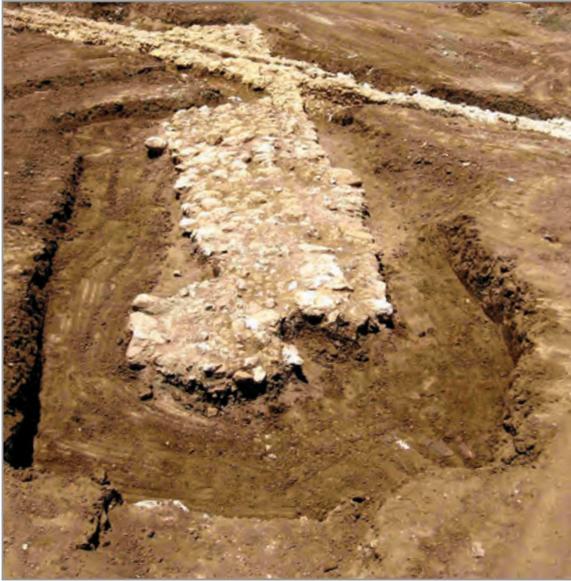
Figure 16. Area C, facing northwest: the stone surface south of the aqueduct.

During the IAA's test excavation a one-course, 0.8m-thick wall (W005) was found projecting southeastward from the aqueduct's southern wall at a 48° angle. An excavation square was opened in order to expose the continuation of this wall. During the excavation another leveled stone area was discovered, this one measuring 10 x 3.5m. It was also constructed from a single course of medium-sized stones (Fig. 16). However, it is emphasized that this was not the full original extent of the feature. Near the edge of our excavation area a drainage pipe had cut the stone surface. It was possible to see in the baulk section that the feature continued to the east of the disturbance, running under a modern road (associated with the adjacent Route 6).

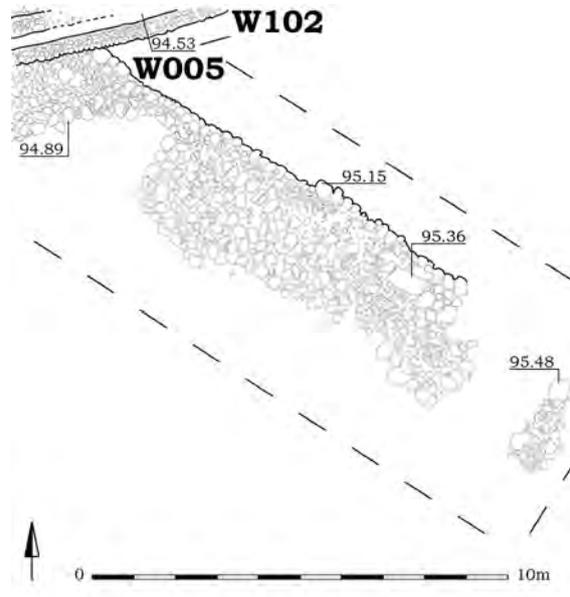
Figure 17. Area C: the stone surface revealed.

We decided to extend the limits of our excavation to the southeast in order to document the full extent of the stone surface and ascertain its function. The drainage pipe damage was 1.5m long; beyond it was an additional 2.3 x 1m surface of small stones (also including two large stones) which was again cut by a water pipe line (Fig. 17). We had extended the excavation in order to find out if the stone surface continued

east of the first drainage pipe disturbance. It seems that the second pipe cut the edge of this surface.
