Salvage Excavation and Documentation of Sites at Nahal Hava – 2009 Preliminary Report

Excavation Permit: B – 334/2009
Excavating Archaeologist: Yehuda Govrin
Y.G. Contract Archaeology Ltd
Academic Sponsor: Hebrew Union College

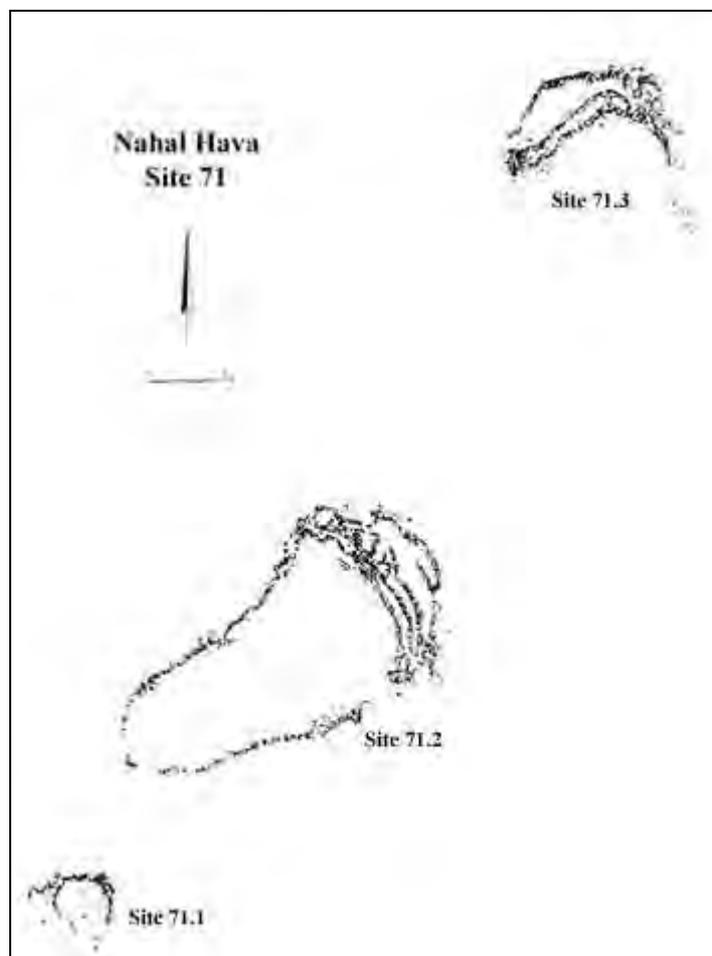
Figure 9: General plan of Site 71, with 71.1-3 marked.

Site 71 (7) was first reported in the IAA's survey as agricultural terraces in a stream. In the salvage excavation that was subsequently required for this area of 50m², we found a unique system for storing water. This was based on networks of stone and clayish soil dams which stored run-off from the wide upstream area. The IAA's decision following this discovery was to excavate an additional 150m² of this system, with the objectives of obtaining a full architectural plan, its date and a better understanding of how this system worked. During December 2009 a number of excavation outings were conducted. In these excavations archaeology students and

volunteers participated. The area was surveyed by a team under Dov Porotsky. The renewed excavation focused on the exposure of the dams' walls by digging sections down to bedrock. The site included a system of two open reservoirs that were built in the center of a shallow stream (71.2-3), as well as a pool for siphoning alluvium (71.1). Three further constructions associated with this water-collecting system were also identified.

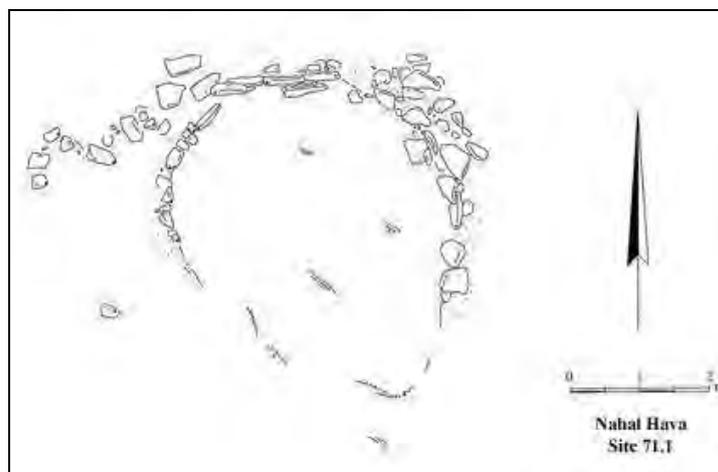
Figure 12: Plan of Site 71.1.

This circle of stones was found at the western extremity of Site 71. Altogether 10m² were excavated here, encompassing the entire feature. It was founded on bedrock, with a diameter of ca.3m. The purpose of this feature was most probably to direct runoff, collecting it over an impermeable rock surface whilst also stopping alluvium and dirt from flowing into the adjacent open reservoir (71.2). The water was hemmed in by natural slabs of medium- and small-sized stones set on their edges. These were supported externally by smaller stones (Fig.11). The eastern side of the pool collapsed and was probably carried away by the nearby stream.

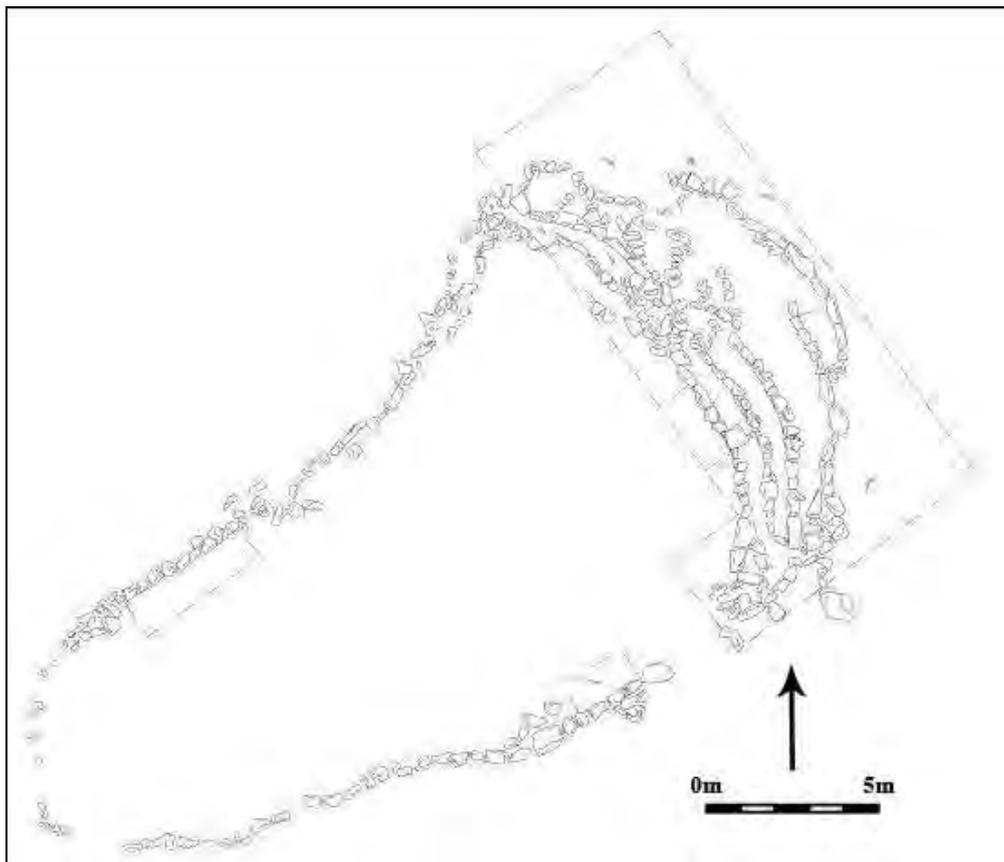
Figure 13: General plan of the Site 71.2 central reservoir after excavation.

Ca.10m east and downstream of the Site 71.1 alluvium-siphoning installation was built an elliptical water storage pool or open reservoir. This measured 25m in length and ca.10m in width. Over the two excavation phases an area of 135m² was dug here, out of a total of 250m². The pool was bordered by large upright fieldstones set on bedrock and stabilized by small stone wedges (Figs.19, 20).

At the eastern edge of the pool (i.e. facing the current), five stone walls were uncovered. These were built at intervals of 1-2m, the gaps between them filled with artifactually-sterile clayish soil (perhaps sediment from Site 71.1). This series of walls formed a composite dam, a reinforcing design founded on bedrock in order to minimize reservoir leaking and erosion by the adjacent stream. A section dug to bedrock on the west side of this dam revealed that its west wall was preserved to a height of ca.1.2m above bedrock (Fig.14). This was built from large and medium-sized stones placed one on top of the other without mortar. Most of the stones were set on their edges, except for the first course which were placed flat on the bedrock. The dam walls were lower towards the east, in accordance with the area's topography. The eastern walls were also built with larger, more rectangular stones stood upright.

In the northeastern corner of the reservoir the sloping bedrock floor on top of which the walls of the dam were built was uncovered. Approximately 5m of the walls were excavated. Here the dam is comprised of two parallel walls built directly on bedrock. The gap between the walls is ca.0.5m, widening gradually towards the center of the dam (Fig.18).

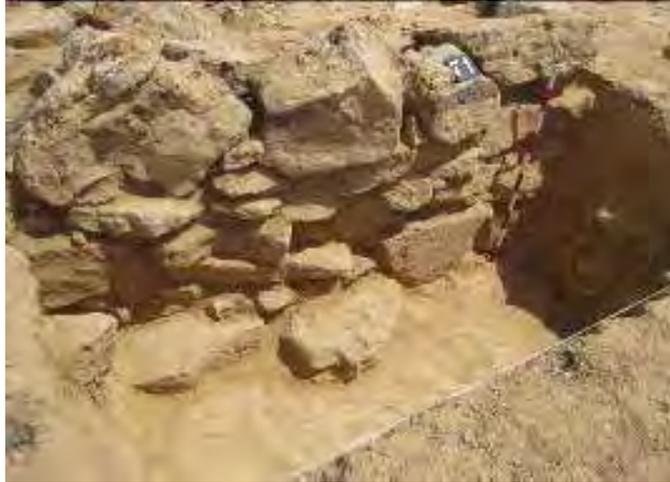
Figure 14: The west side of the Site 71.2 dam's west wall, preserved to a height of 1.2m above bedrock.

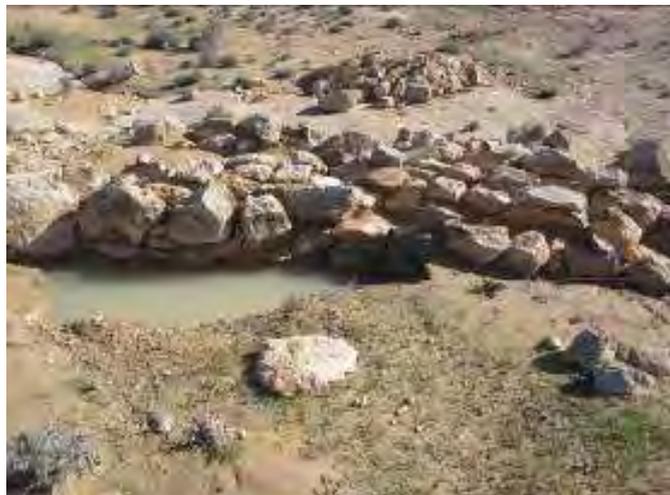
Figure 15: The dam's western wall holding water.

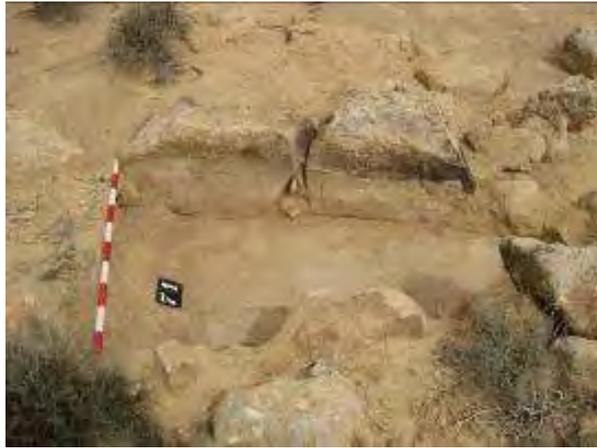
Figure 17: The dam's eastern courses resting on bedrock.

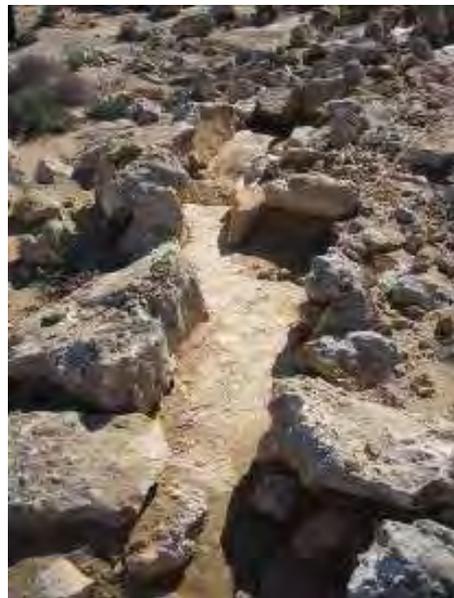
Figure 18: The north end of the dam.

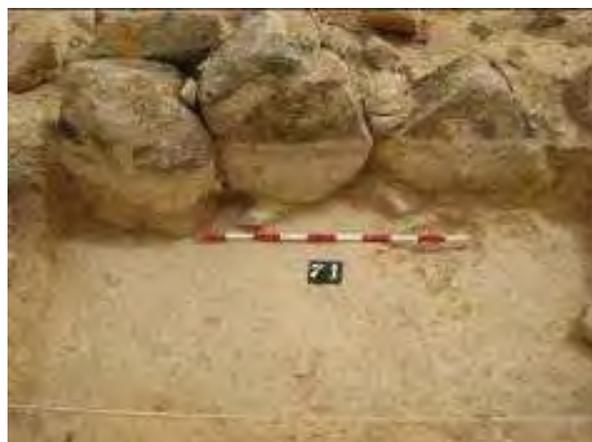
Figure 19: The southern end of the dam wall, a single course of large stones.

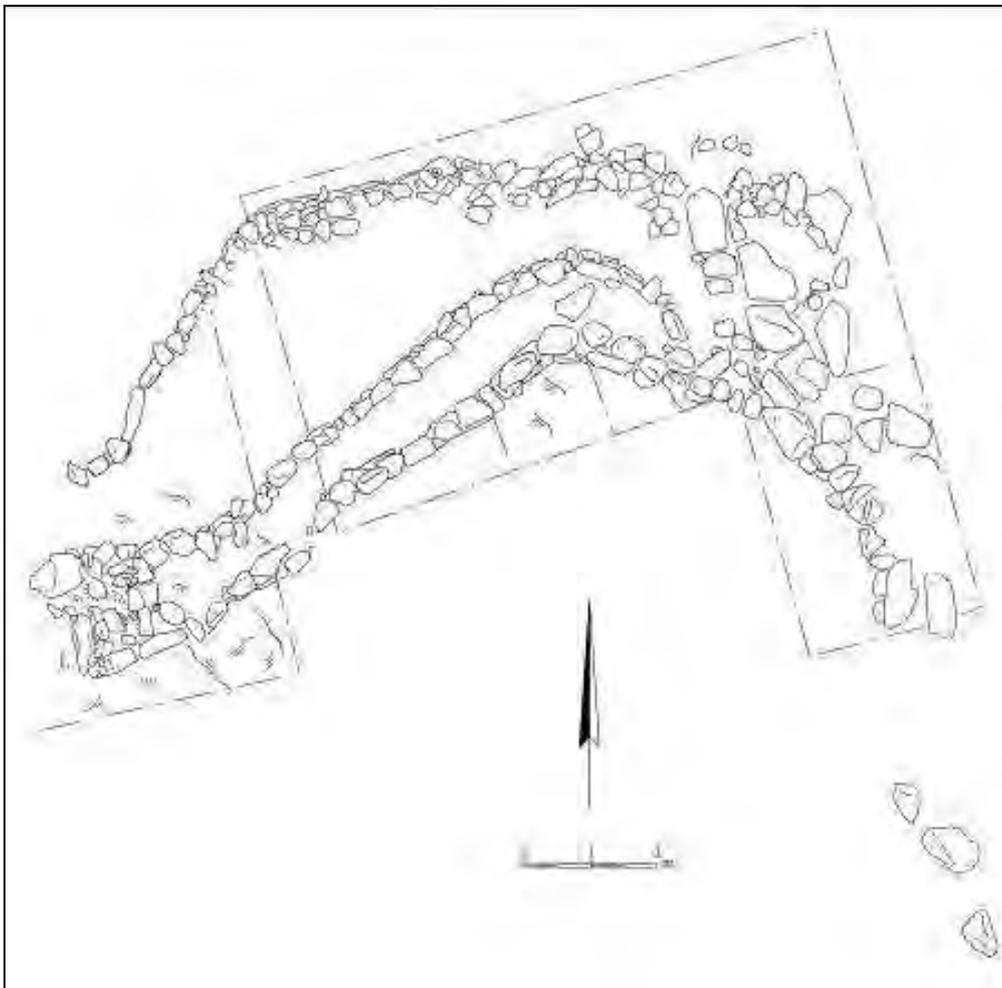
Figure 23: Plan of the dam wall system of the Site 71.3 eastern reservoir, with the compartment of upright stones on the west side.

An additional water storage pool was found downstream and northeast of the 71.2 central reservoir, the overflow from which this second pool served to catch. Like 71.2, it was also built directly on the hard, seamless limestone rock which constitutes the stream's floor. In this eastern reservoir a total of 80m² were opened. The dam of this pool was built of three supporting walls, the gaps between which were filled with a clayish alluvial soil (Figs.24, 28-29). Two of the walls were parallel (Fig.26) and found 1m apart, and the third was a further 3m to the east. On the east side of the dam, the wall was preserved to a height of 1.2m above bedrock. As with the other Site 71 features, this reservoir's walls were built of large upright stones standing on the bedrock. The upper courses were laid with stones set horizontally.

On the west side of the dam was situated a 1 x 1m compartment filled with a number of large stones standing upright (Figs.25-27). This compartment does not have any functional need and may therefore be of a symbolic or ritual nature, with the upright stones tentatively thought of as stelae of a sort.

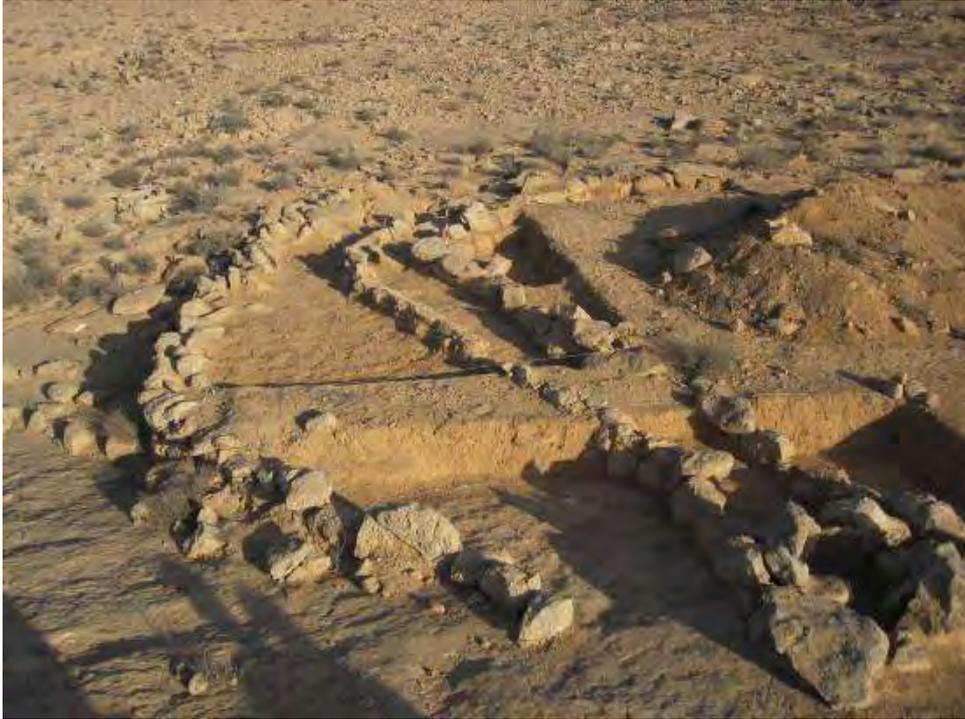
Figure 24: General view of the three supporting walls of the Site 71.3 dam. In the right foreground is the possible ritual compartment.

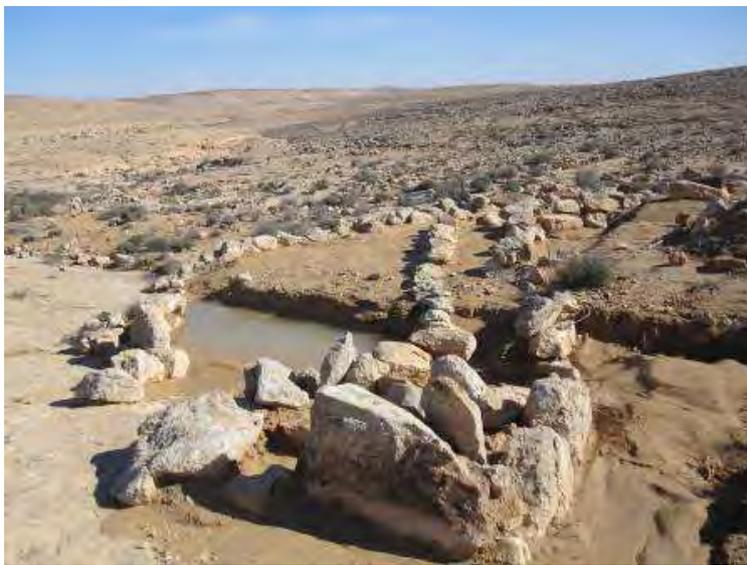
Figure 28: General view of the 71.3 reservoir's dam walls after the flow of run-off in the stream. In the foreground is the stelae compartment at the end of the dam walls.

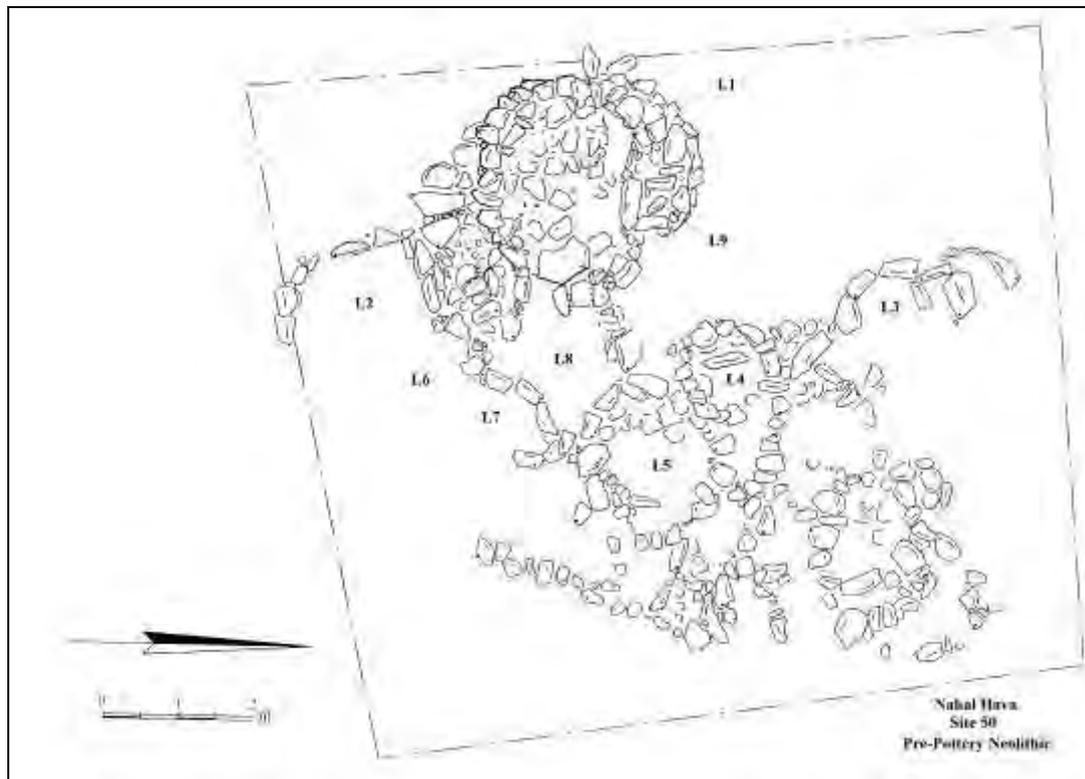
Figure 57: Plan of the Site 50 main structure and excavation area.
