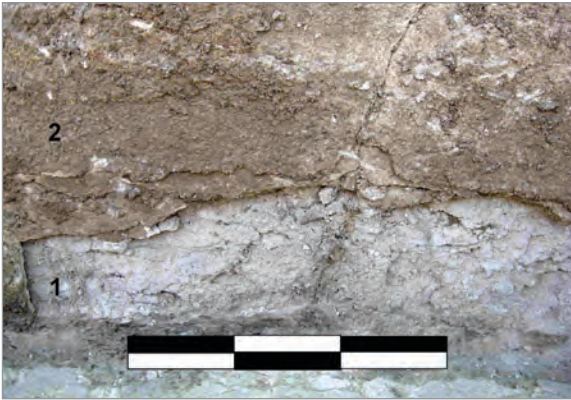
Figure 7. Area A: The two layers of plaster from the section where the northern wall was removed, earlier layer (1) and later layer (2).

The aqueduct was built by laying a 0.3m-high bonded fieldstone foundation, upon which were built two parallel walls 0.4m apart. The channel's slope was very gentle, measuring 0.05° over the length of the area. Two layers of plaster were clearly discerned (Fig. 7): the earlier reddish in color, with quartz grain and potsherd inclusions, and the later layer grayish in color due to water-induced accretions.

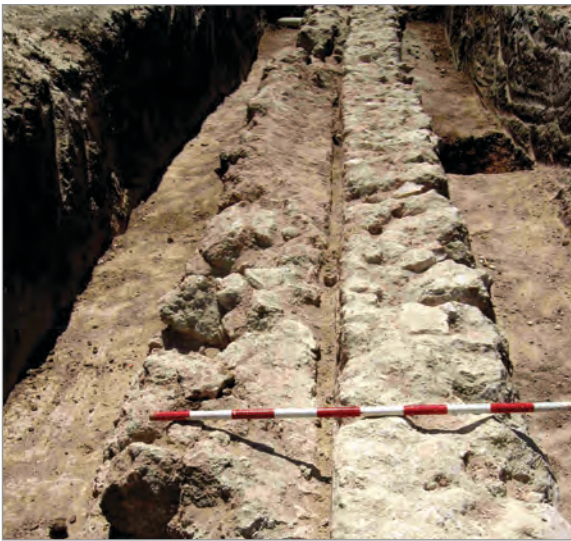
Figure 8. Area A, facing southwest: the eastern section of the excavated aqueduct. The angle of Wall W102 (left) can clearly be seen.

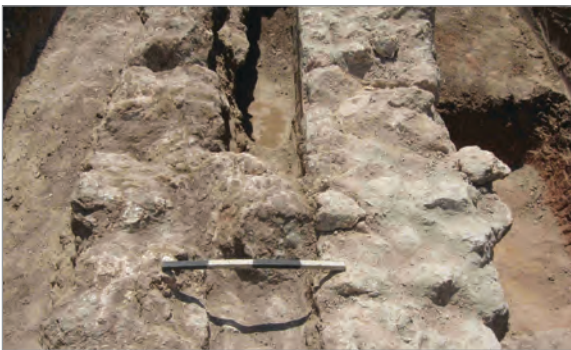
Figure 9. Area A, facing southwest: a large stone lodged in the interior of the aqueduct.

In this part of the aqueduct Wall W102 was constructed from seven courses of limestone. The six lower courses were built of medium-sized, bonded fieldstones. The upper course was built from larger stones cut into roughly regular blocks. As in the first stage, evidence of a later robbery of stones from the upper course of this wall could also be seen. The height of the wall from the base of the channel was 1.2m and its width was 0.55-60m. This wall collapsed to the north similar to the Stage 1 area (Fig. 8), except at one point where a large stone was found in the interior of the aqueduct, keeping the wall from collapsing (Fig. 9).

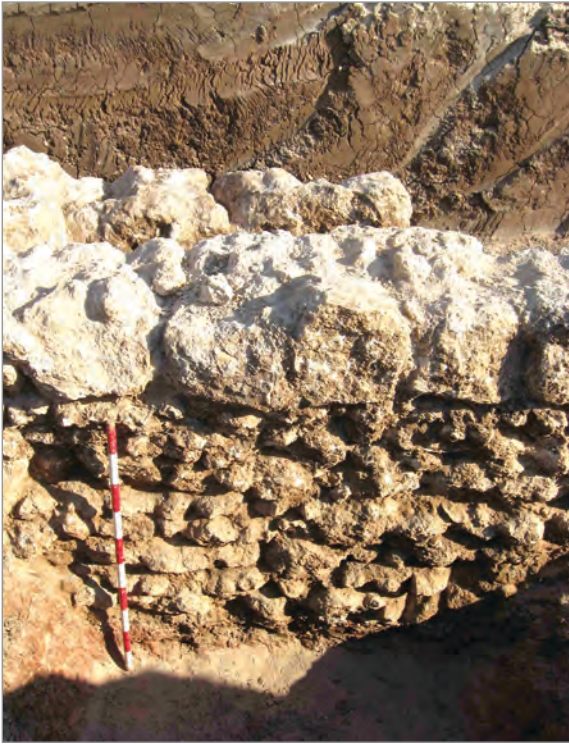
Figure 10. Area A: the north side of W103.

Wall W103 was identical to the southern wall described above and was comprised of seven courses of limestone, the six lower courses built of medium-sized fieldstones bonded by cementing material and an upper course built from larger semi-dressed blocks. The height of the wall from the base of the channel was 1.2m and again it was 0.55-60m wide. A deep square (1 x 1.6m) was excavated beside the wall here in order to examine its construction (Fig. 10).

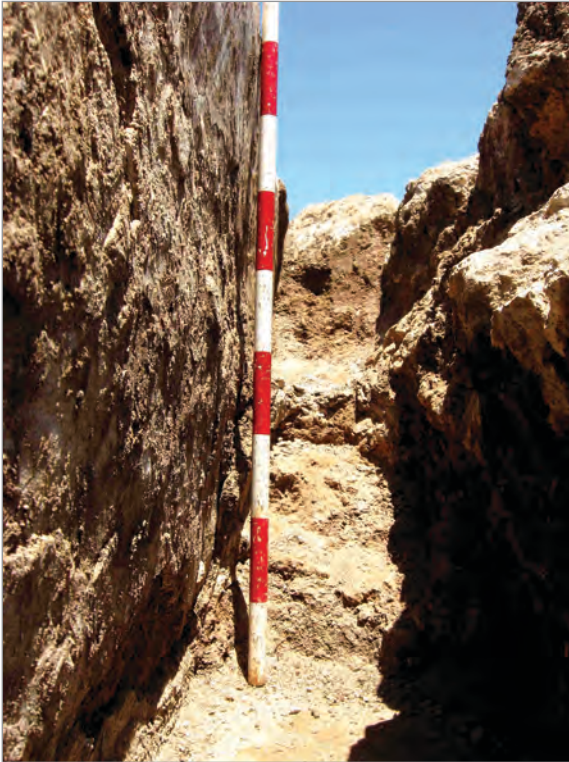
Figure 11. Area A: the interior of the aqueduct.

the 0.4m width of the channel. The depth of the interior of the aqueduct here was 0.92m from the base to the extant top of the enclosing walls (Fig. 11). In this section also two layers of plaster were found in the interior of the aqueduct.

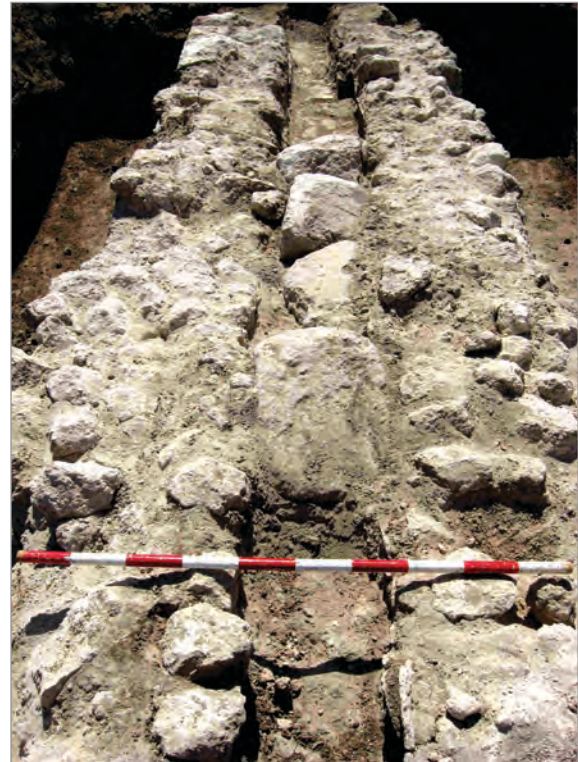
Figure 12. Area B, facing west: the aqueduct at the western end of the excavation.

The wall here was constructed from four courses of limestone. The three lower courses were built of medium-sized, bonded fieldstones. The upper course was built from larger semi-dressed blocks. The height of the wall here, from the base of the channel, was only 0.55m and its width 0.55-60m. In this section both of the walls maintained their rectitude, probably not collapsing because the lower walls here reduced the pressure exerted on them from the surrounding soil, and due to four large stones which here also had collapsed into the channel and helped shore up the wall (Fig. 12).
