The current excavation contributes to our corpus of knowledge regarding the *Kaanatt Benth el-Kaffar* aqueduct. Firstly, we have learned something of the construction's taphonomy, what it underwent after it had gone out of use. Furthermore, we have learned more about the different techniques used in order to maintain the aqueduct's route in an area of difficult terrain.

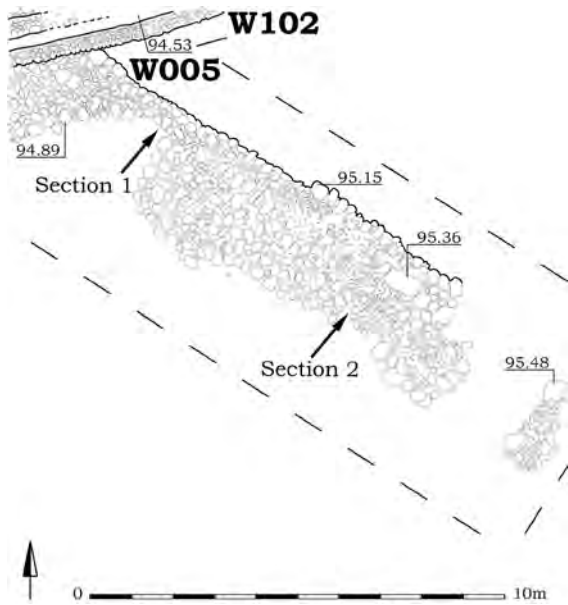
Figure 18. Area C: the location of the test sections.

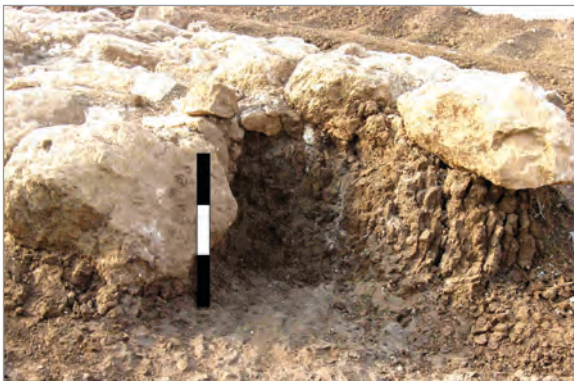
Figure 19. Area C, facing northeast: Section 1 where Wall W005 (left) met the stone surface (right). Notice the difference in depth between the two features.

- 1). Already in ancient times it was understood that heavy clayish alluvial soil of the kind found in this area can be problematic for certain construction types. The IAA test excavation revealed that external reinforcements – i.e. W101, W005, and the stones surface north of the aqueduct – were built in places of such difficult soil in order to preserve the aqueduct’s walls. These reinforcements were effective. By contrast, for some reason no reinforcements were put in place in the area of the current excavations and as a result the unforgiving soil caused its southern wall to collapse into the aqueduct.

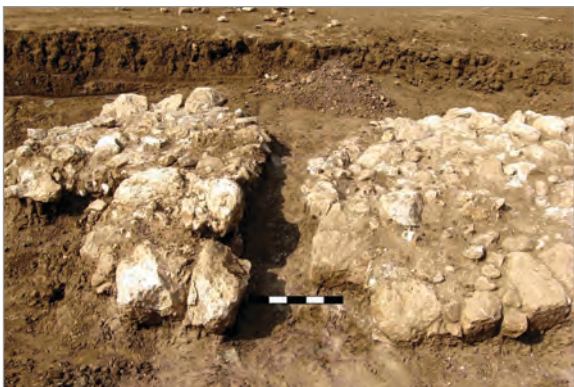
Figure 20. Area C, facing southwest: Section 2.

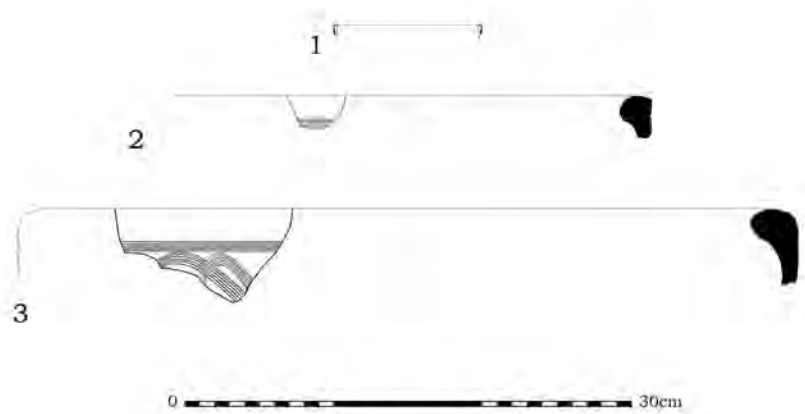
Figure 21. Finds.

No.	Object	Period
1	Glass vessel	
2	Bowl	Umayyad/Abassid
3	Bowl	Umayyad/Abassid

Only a few pottery fragments were found. However, we did recover two indicative rims of Islamic-period bowls (Fig. 21:2,3) and a small sherd from a glass vessel (Fig. 21:1). North of the aqueduct we found a concentration of many fragments from a vessel with signs of burning on its exterior and plaster remains on the interior. Perhaps this vessel was associated with the preparation of the aqueduct plaster.
