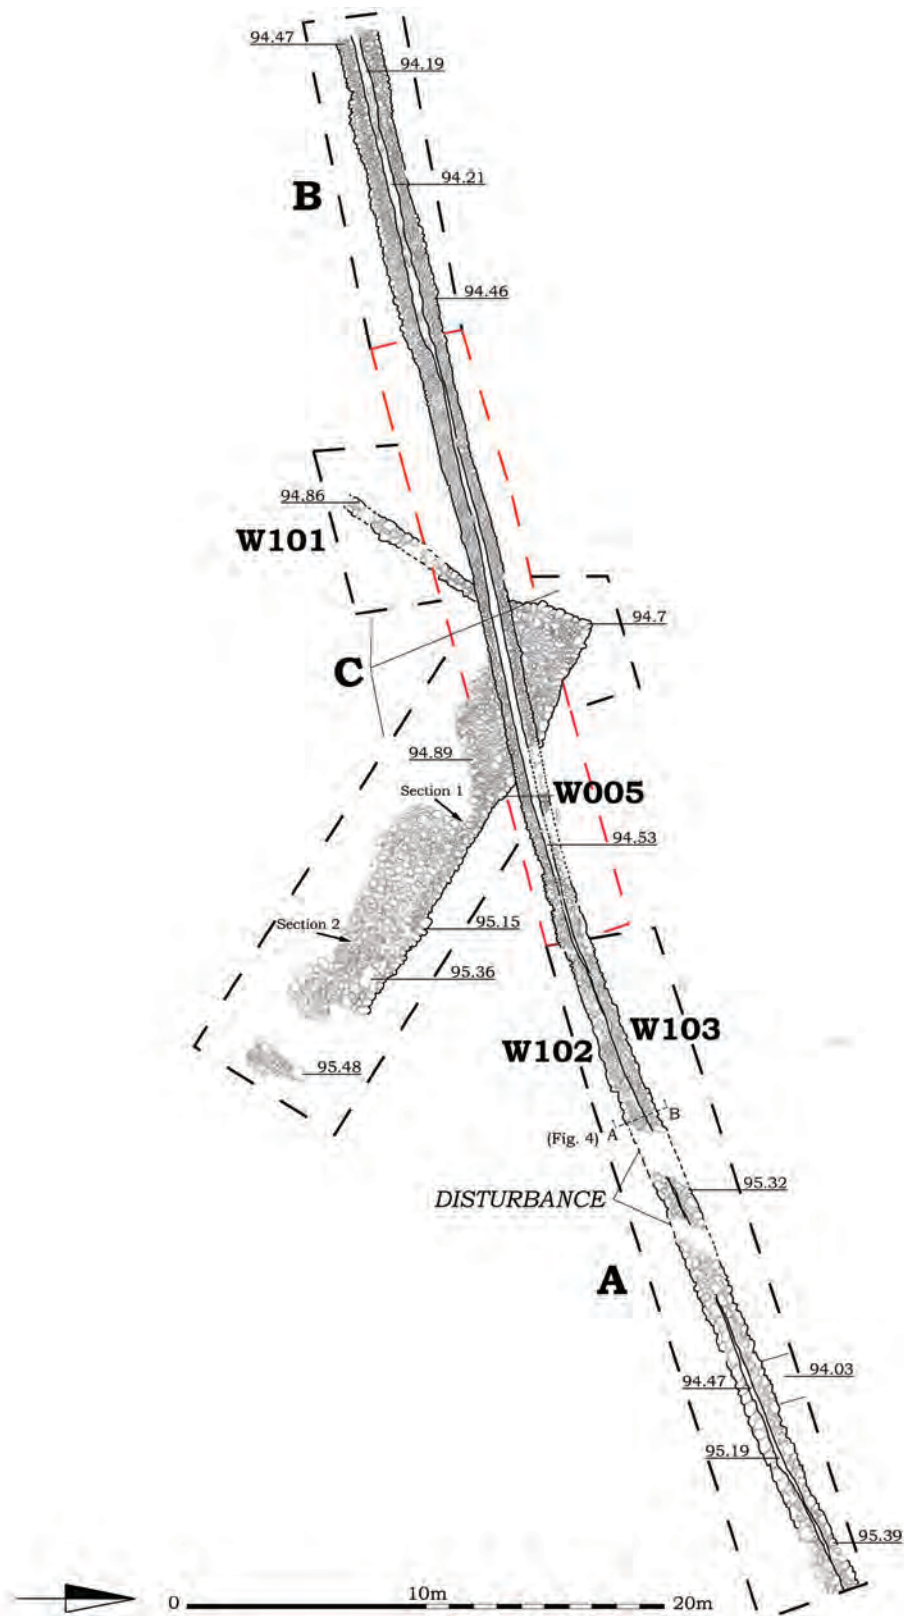
Figure 3. The different areas in the excavation, the Israel Antiquities Authority test excavation enclosed by the red frame.

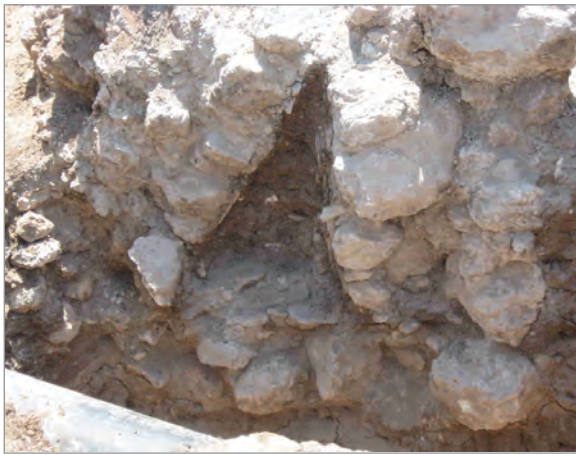
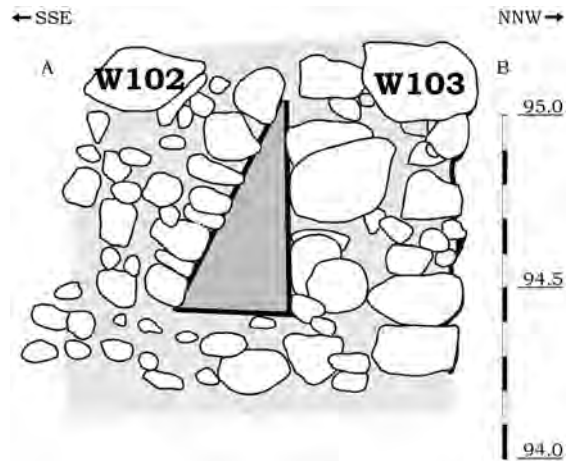
**Figure 4.** Area A: Section photograph and drawing of the aqueduct at the point of disturbance.

and at a right angle to the aqueduct's base. In section it was revealed that the southern wall had fallen into the channel and rested at an average angle of  $61^\circ$  (Fig. 4). The cause of the collapse of the southern wall was the heavy, moisture-retaining, clayish alluvial soil of the area. The continued pressure of this heavy sediment forced the southern wall over to such an angle, and led to the channel being covered after it fell into disuse.

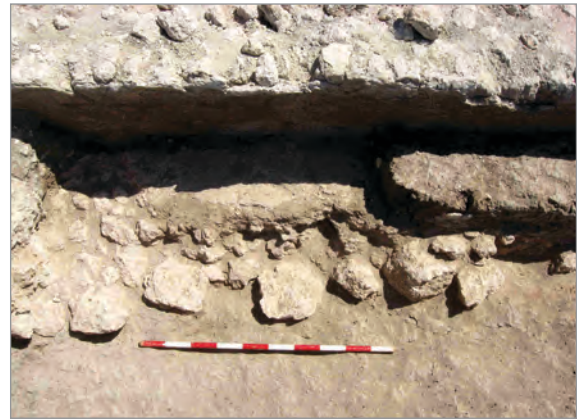
**Figure 5.** Area A, facing southeast: The foundation stones of the northern wall (W103) of the aqueduct in the stone robbery area.

This wall was built with a technique similar to Wall W102: five courses of limestone and bonding material, with the four lowest courses made up of medium-sized fieldstones and the upper course from larger roughly-chiseled stones. Like its southern counterpart, the wall's height from the channel base was 1m, but at 0.50-55m wide was slightly narrower than W102. Yet despite this, the northern wall maintained its original shape and still stood vertical at a right angle to the aqueduct channel's base. This wall was the focus of later stone scavenging, by which a 3.1m section of the wall was robbed out entirely (Fig. 5). An approximate date was ascertained for the time of stone scavenging by studying the plaster remains in the missing section of the wall. There a layer of plaster without any stones was found on top of the channel's fill, 0.15m above the aqueduct's interior surface (Fig. 6). It was thus deduced that the stones were robbed after the channel had been abandoned and filled up with 0.15m of alluvium.

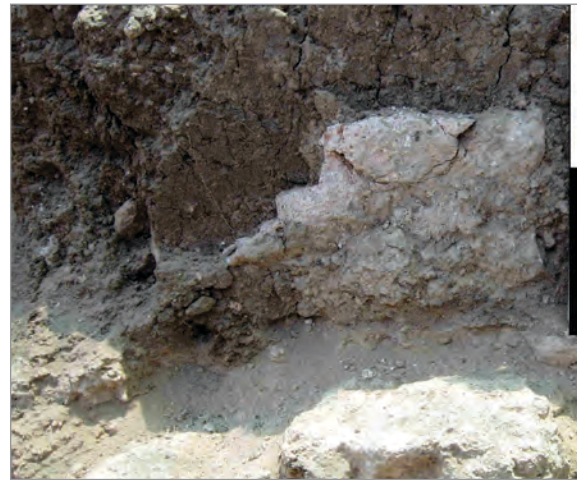
**Figure 6.** Area A: Plaster remains over the aqueduct's fill in the area where the northern wall was removed.
