# Salvage Excavation of an Aqueduct at Naan Kaanatt Benth el-Kaffar (East) - 2009 Final Report

Excavation Permit: B - 339/2009 Excavating Archaeologist: Eli Cohen Sason Y. G. Contract Archaeology Ltd Academic Sponsor: Hebrew Union College

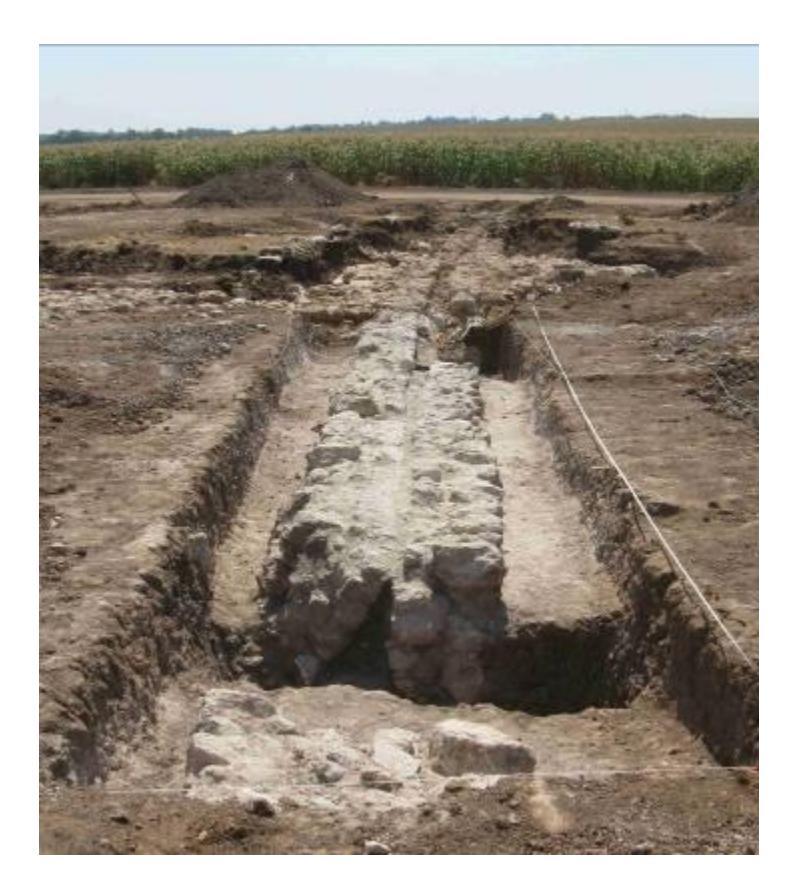
Figure 1: General view of the excavated aqueduct, photographed from east to west.

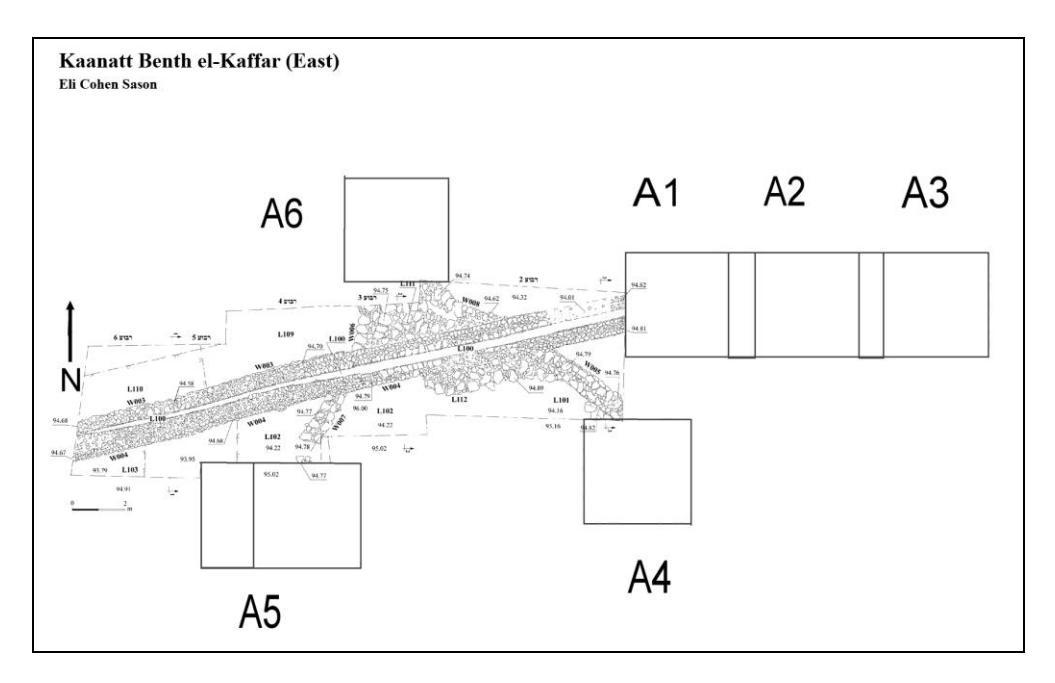
Figure 3: Location of the excavation squares overlaying the plans of the test excavation carried out on behalf of the IAA (courtesy of Ron Toueg, IAA Central District).

The excavation included six 4 x 4m squares (Fig.3), three along the aqueduct's path towards the east (A1, A2, A3) and three additional ones (A4, A5, A6) in order to investigate a branching out of the aqueduct's path that was discovered during the area's test excavation on behalf of the IAA.

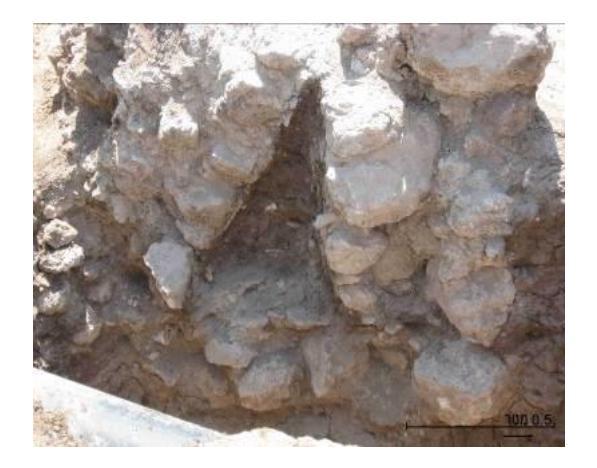
Figure 4: Section of the aqueduct where cut by later drain pipe disturbance.

In this area an additional 14.40m of the aqueduct were excavated along an approximately east-west axis. A 2m-long disturbance in the aqueduct's path was exposed, in which a drain pipe had been placed in recent years. Our excavations confirmed the consistency of what previous work had shown: the aqueduct was constructed by the placement of a foundation of fieldstones with cementing material at a height of 30cm. On top of this were built two parallel walls, between which ran the aqueduct's water channel.

From the test section that was excavated through the aqueduct in the area of the later disturbance it can be seen that most of the stress acted on the southern wall, all of which collapsed northward and essentially sealed the aqueduct channel. By contrast, the northern wall retained its vertical form throughout the centuries. This wall was the focus of a later stone robbery carried out after the aqueduct had fallen into disuse (but not considerably later, as we can infer from the presence of plaster immediately overlying the aqueduct's fill).

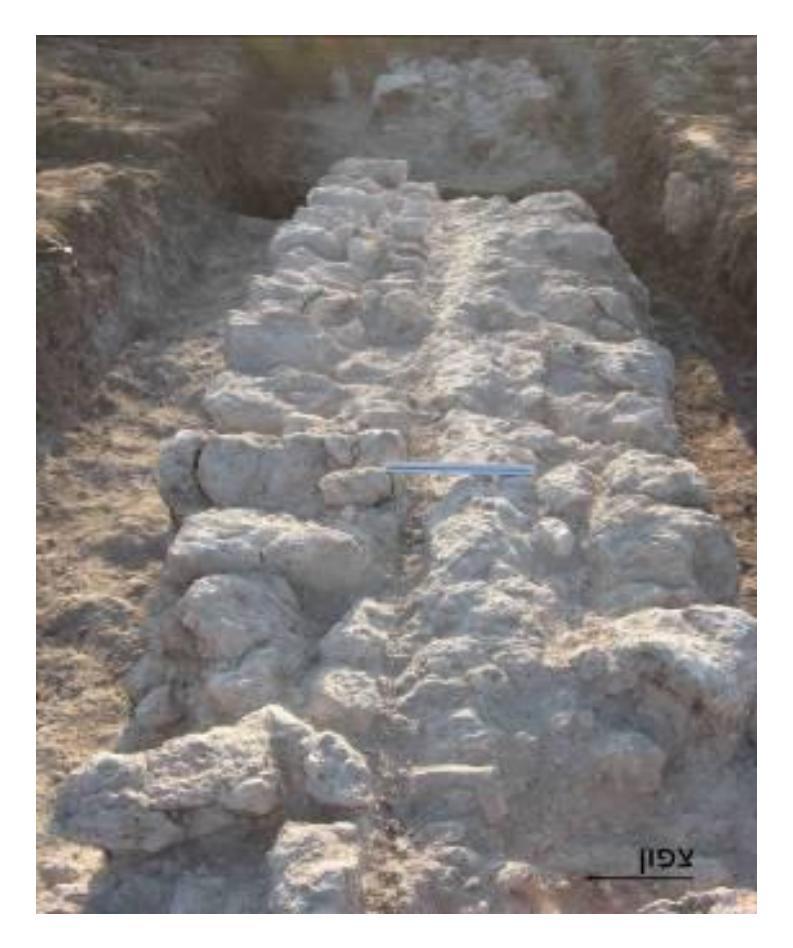
Figure 5: The aqueduct's walls (view from above).

The wall was constructed from four courses of limestone. The three lower courses were built of medium-sized fieldstones bonded by cementing material. The upper course was built from larger stones chiseled to rectangular shapes. Evidence of a later robbery of stones from the upper course of this wall can be seen. The height of the wall from the base of the channel is 1m and its thickness is 55-60cm. It is possible to distinguish between two layers of plaster on the northern side of this wall (the interior of the aqueduct). The earlier (inner) layer had a reddish color, and quartz grain and potsherd inclusions. The later layer had a grayish color with evidence of accretion as a result of water running through the aqueduct. In accordance with the results of excavations at the aqueduct approximately 200m east of the current excavation (Gorzalzani 2005), it appears that the two walls of the channel were built parallel at a right angle to the aqueduct's base. In the current excavation's section of the aqueduct it can be seen that the southern wall fell into the channel and was found at an average angle of 61° (Fig.4). The reason for this is that the soil in the excavated area is a heavy clayish alluvial soil that is very prone to soil creep, due to its high moisture absorption and retaining capacity. The continued pressure of this heavy soil caused the southern wall to tilt at such an angle, and led to the channel being covered after it fell into disuse.

This wall is built in a similar manner to wall W102: four courses of limestone and bonding material, with the three lowest courses made up of medium-sized fieldstones and the upper course from larger roughly-chiseled stones. Like its southern counterpart, the northern wall's height is 1m from the channel's base, but at 50-55cm it is slightly narrower. Yet despite this, the northern wall maintained its original shape and still stands at a right angle to the aqueduct channel's base. This wall was the focus of later stone scavenging, by which a 3.10m section of the wall was robbed of all its courses (Fig.7). An approximate dating can be given to the time of robbery by the remains of plaster in the missing section of the wall. There a layer of plaster without any stones was found on top of the channel's fill, 15cm above the aqueduct's interior surface (Figs.6-8). That is, the stones were robbed after the channel went out of use and filled up with 15cm of alluvium.

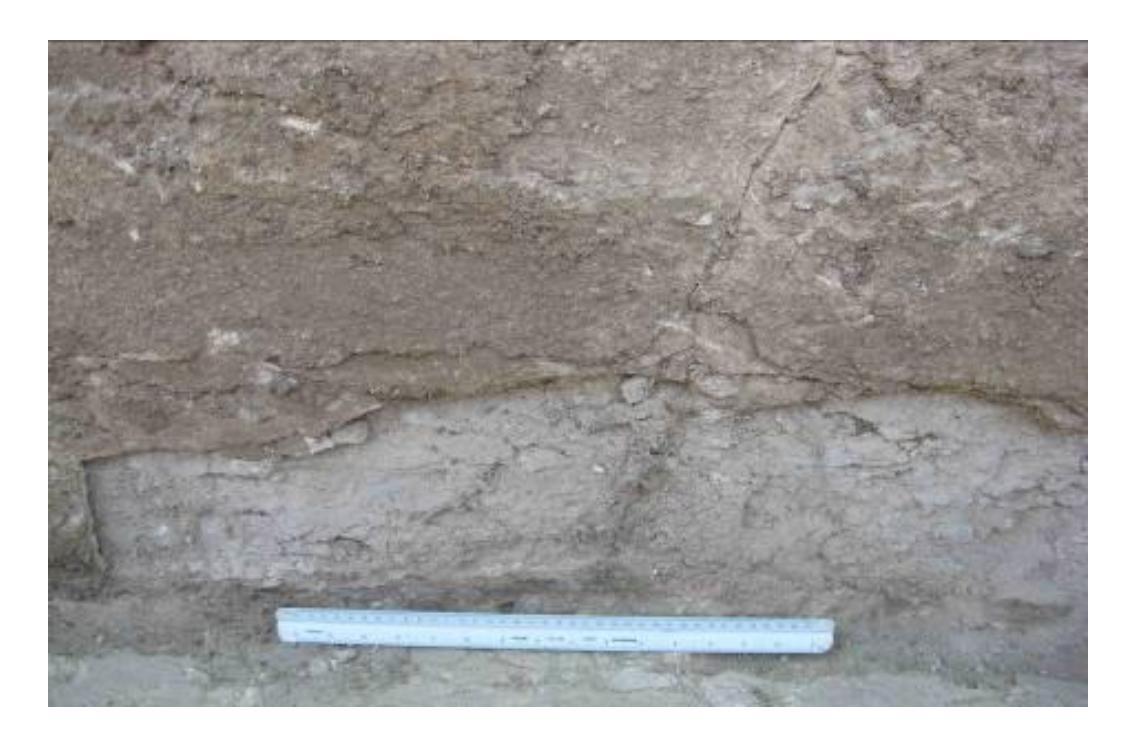
Figure 6: The two layers of plaster from the section where the northern wall was robbed.

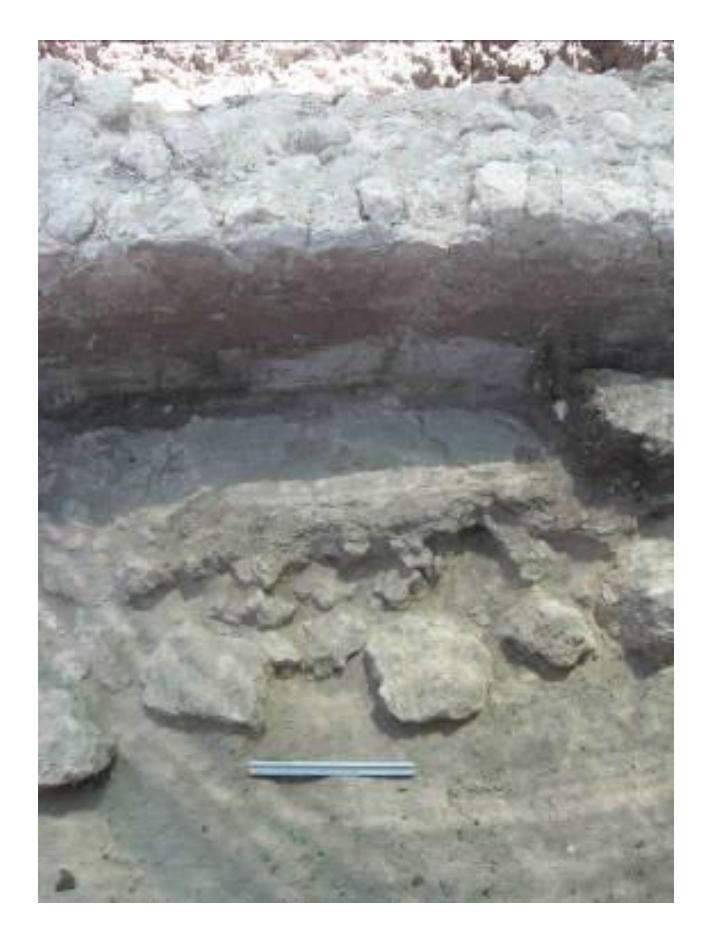
Figure 7: The stone foundation with the aqueduct channel's plastered surface on top of it, in the area where the northern wall was robbed.

The aqueduct was built by laying a 30cm-high fieldstone foundation with cementing material, on top of which a smooth layer of plaster was applied to a width of 40cm (the distance between the two walls of the channel). The channel's slope was graduated, measuring 0.05° over the length of the excavation area.

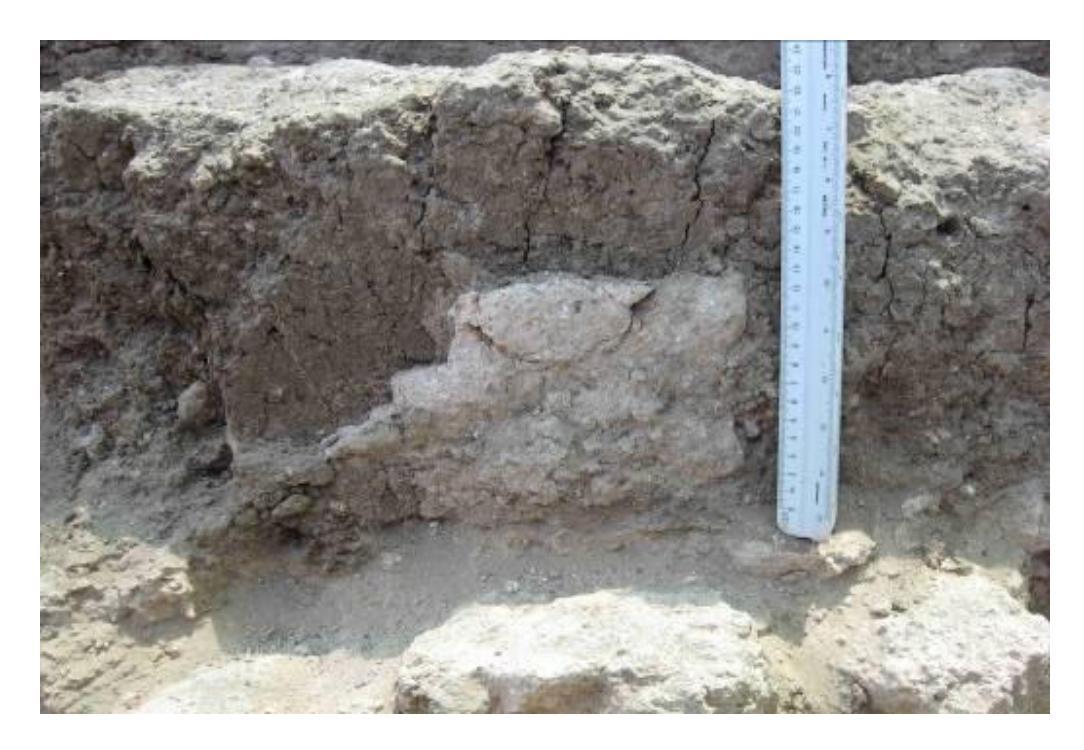
Figure 8: Plaster remains on top of the aqueduct's fill in the area where the northern wall was removed.

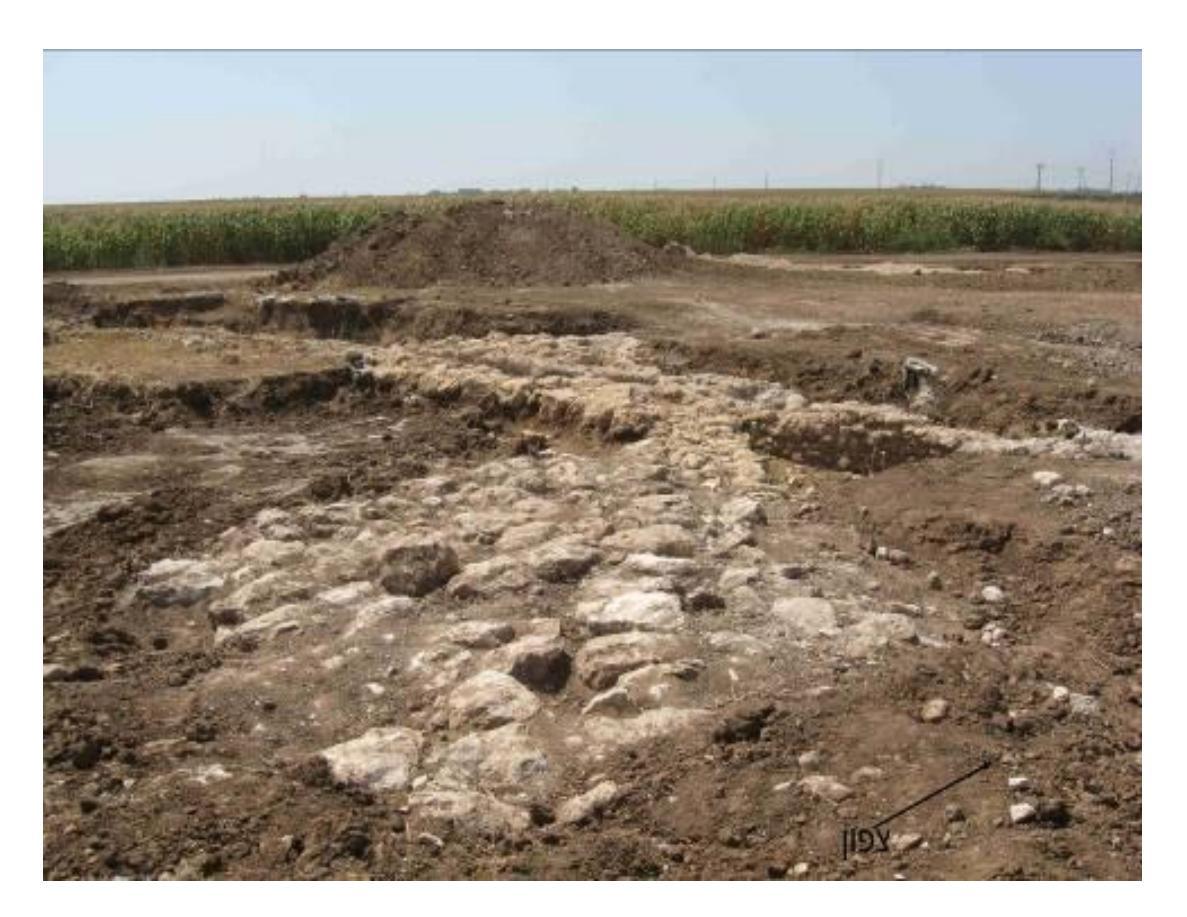
Figure 9: Square A4 and behind it the IAA-excavated aqueduct section.

In the IAA's test pit a one-course, 80cm-thick wall was found projecting southeastward from the aqueduct's southern wall at a 48° angle. Square A4 was excavated in order to expose the continuation of this wall (W005). Instead, a well-leveled single course of medium-sized fieldstones was uncovered filling almost the square's 5m<sup>2</sup> (Fig.9). The limits of this leveled stone area and the area's function were not revealed, necessitating the opening of two further squares (see below, p.9).

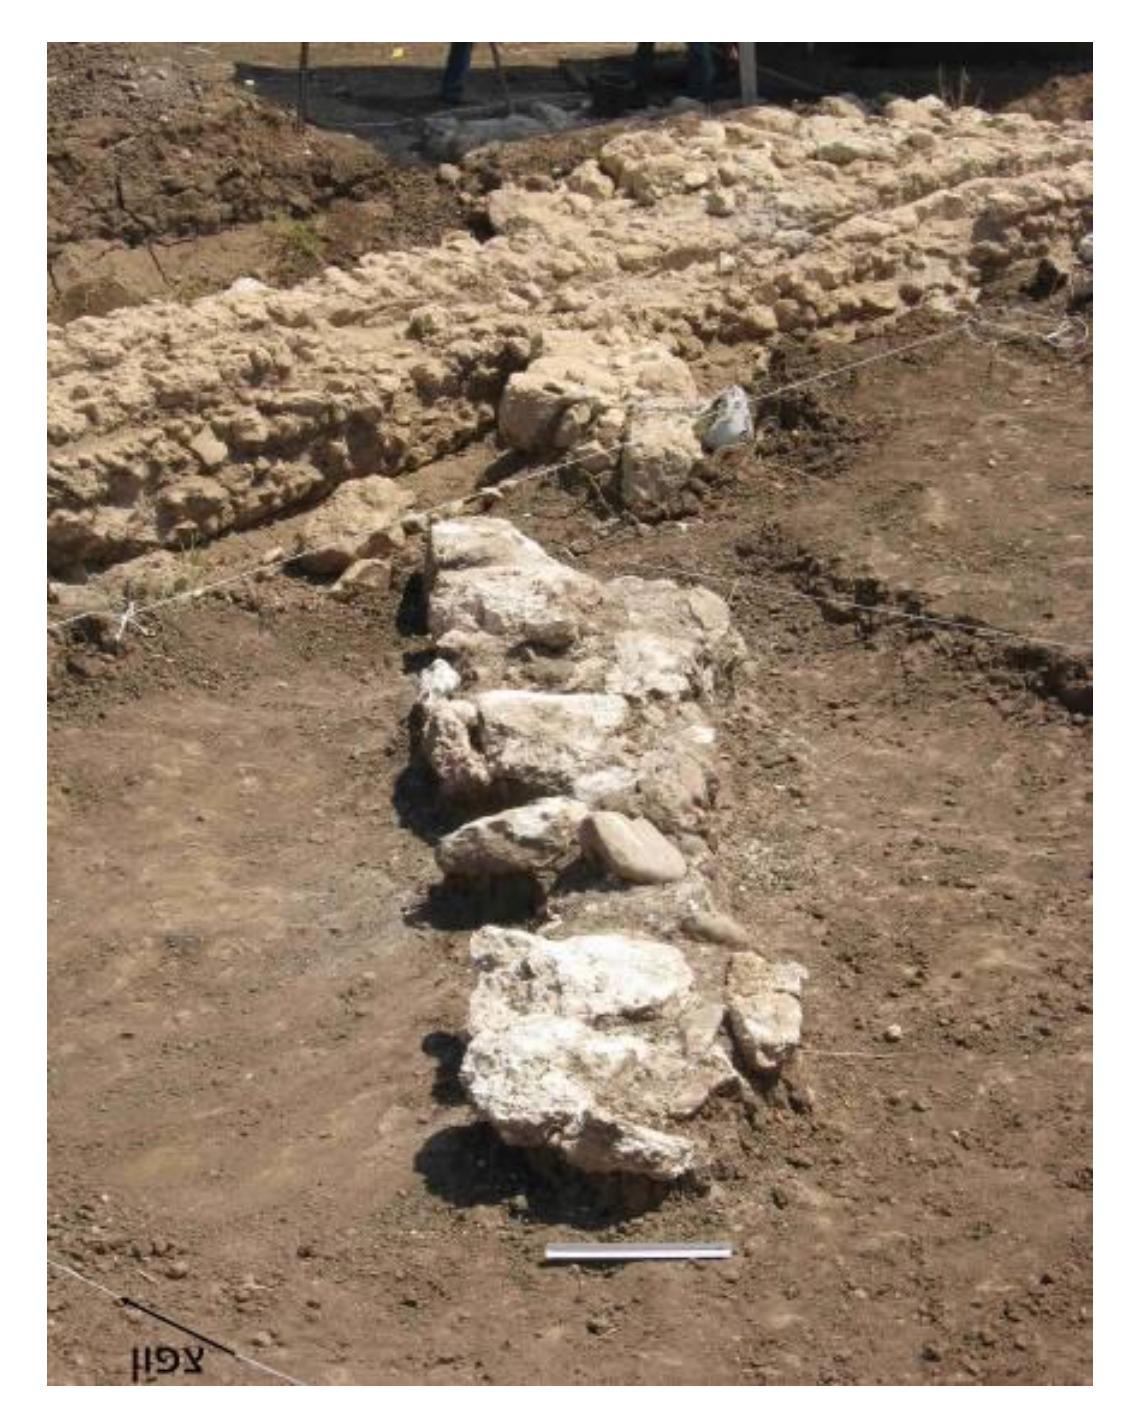
Figure 10: Wall W101, with the IAA-excavated aqueduct in the background.

In the IAA's test pit a 60cm-wide single course wall was found projecting southwestward at an angle of 42° from the southern wall of the aqueduct. Square A5 was excavated in order to expose the continuation of this wall. During the excavation a further 3.4m section of this wall was found (Fig.10). It was built of a single course, 60cm wide. Evidence of disturbance to this wall was found in a section 1.30m long. The wall's extant length from the area where it is attached to the aqueduct to its end is 6.85m (including the missing 1.30m).

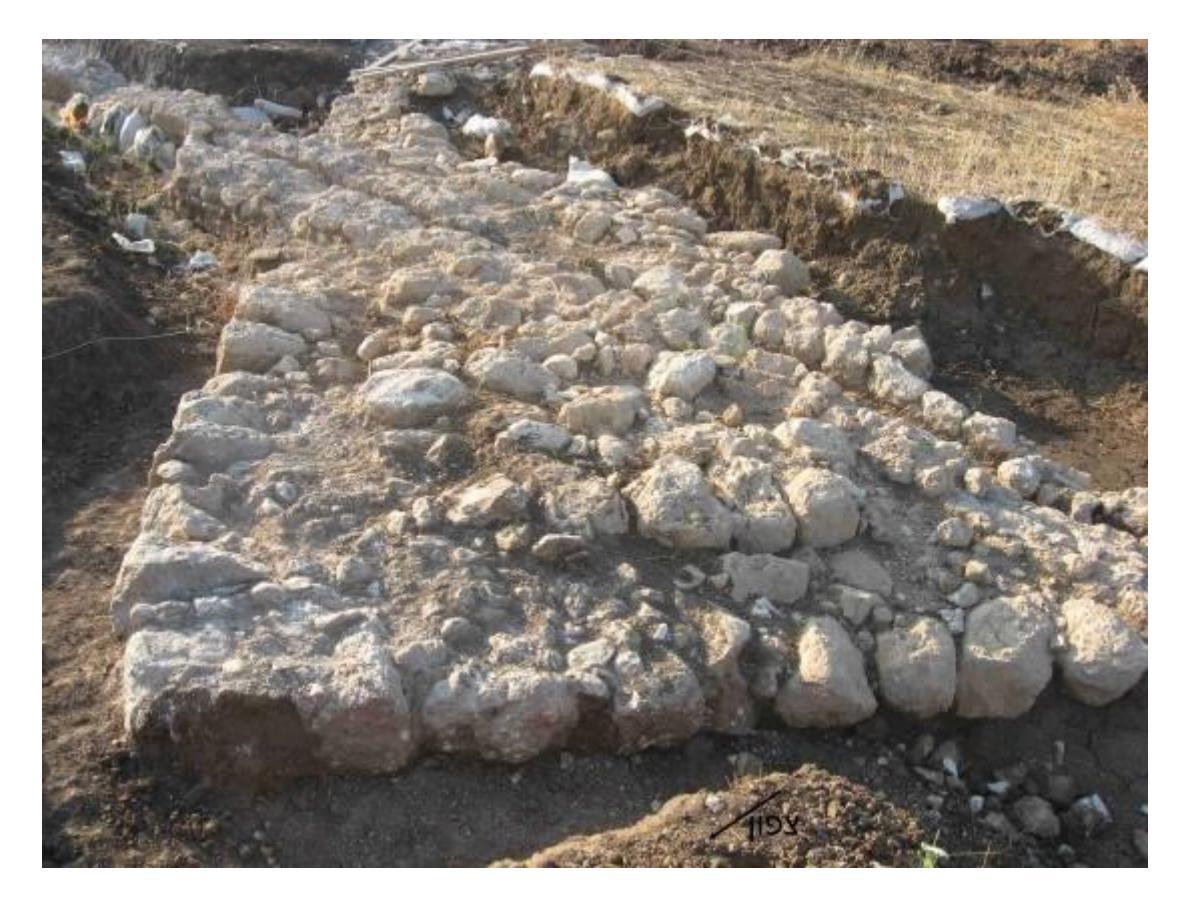
Figure 11: The stone triangle in square A6.

In the IAA test excavation a level area of stones was found projecting from the northern wall of the aqueduct (Fig.11). This square was excavated in order to expose more of this leveled stone area. Its extent was found. The leveled stone area is of a triangular shape in plan, being built of medium- and large-sized fieldstones that were placed in one course and which abut the aqueduct's northern wall. The entire area of the triangle is 9m<sup>2</sup>. The lines of the triangle's edges also extend southeastward and southwestward on the other (south) side of the aqueduct, in squares A4 (W005) and A5 (W101) (see Fig.3).

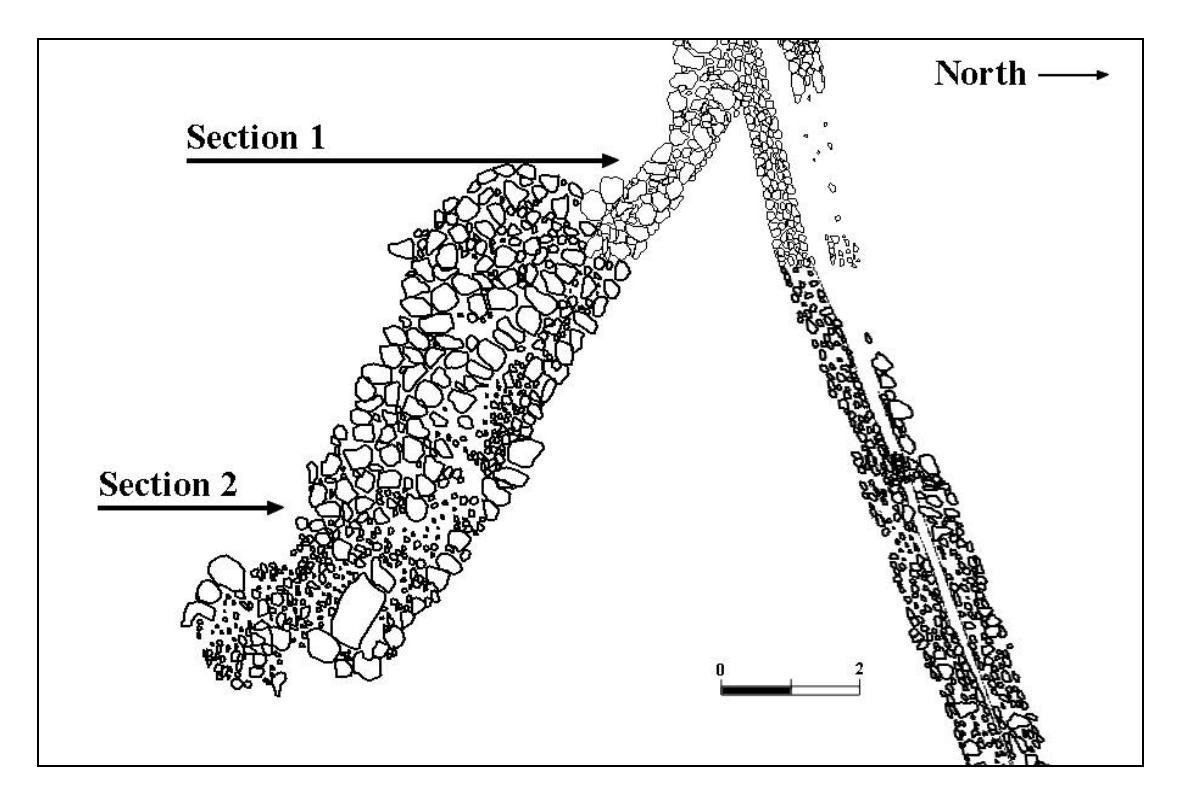
Figure 12: Location of the sections through the leveled stone area.

In order to better understand the nature and function of this feature it was decided to cut through it at two points (Fig.12): the first at the meeting point of W005 and the leveled stone area; and the second through the leveled stone area itself.

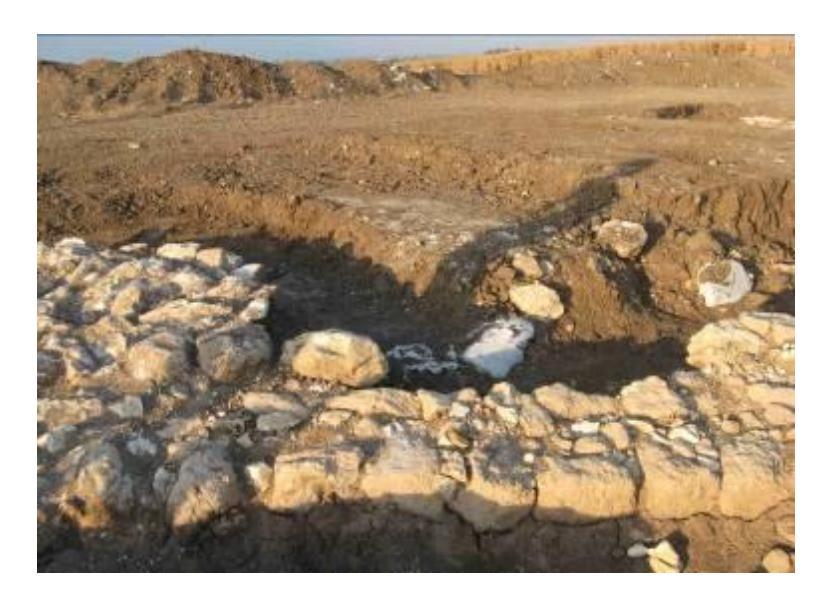
Figure 13: The location of section 1 before the excavation.

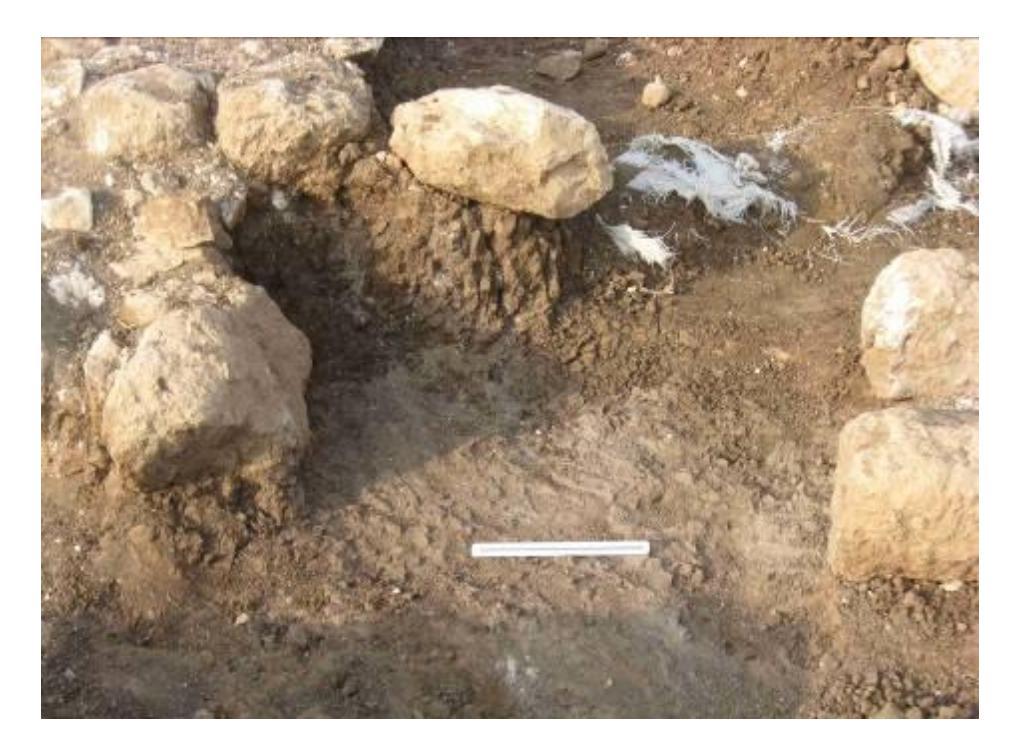
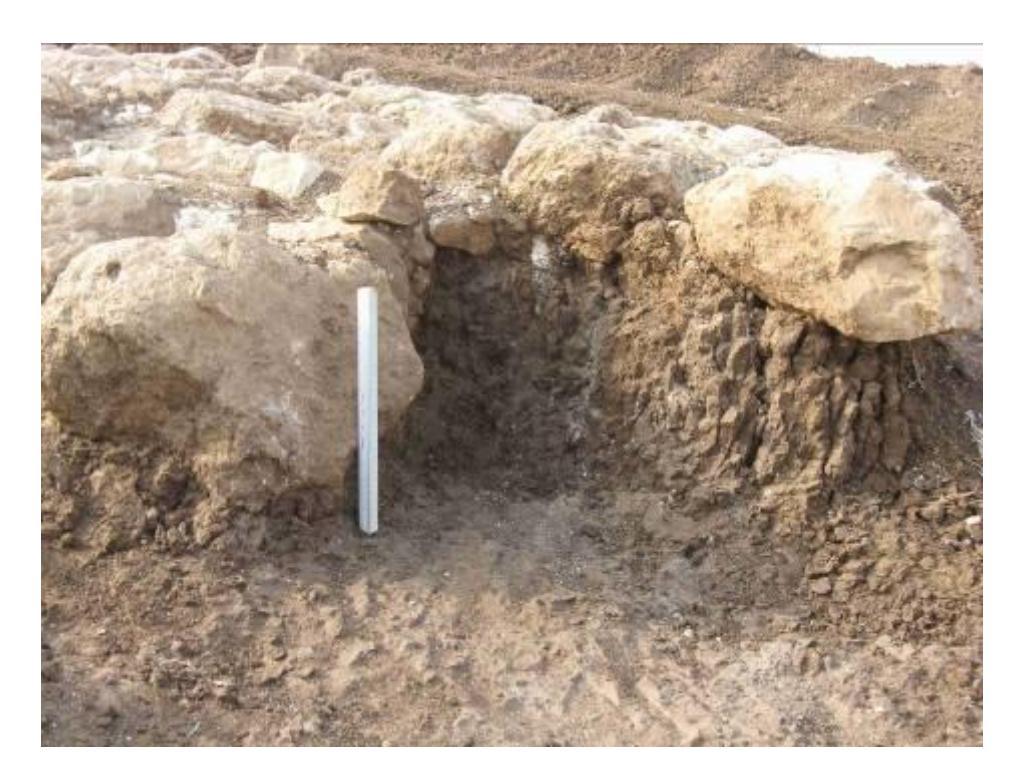
Figure 14: Section 1 after excavation.

Figure 15: Section 1 from the north side, showing the difference between the depths of W005 and the leveled stone area south of them (behind).

In order to make this section, a meter-long cut into wall W005 was excavated 45 cm deep (in order to reach the ground level on which the stones of W005 were placed). However, little information was added about the function of the wall or leveled stone area. The section showed a course of medium-sized stones that were placed on top of the virgin soil, with W005 set 25cm deeper into the ground than the leveled stone area (Figs.14-15).

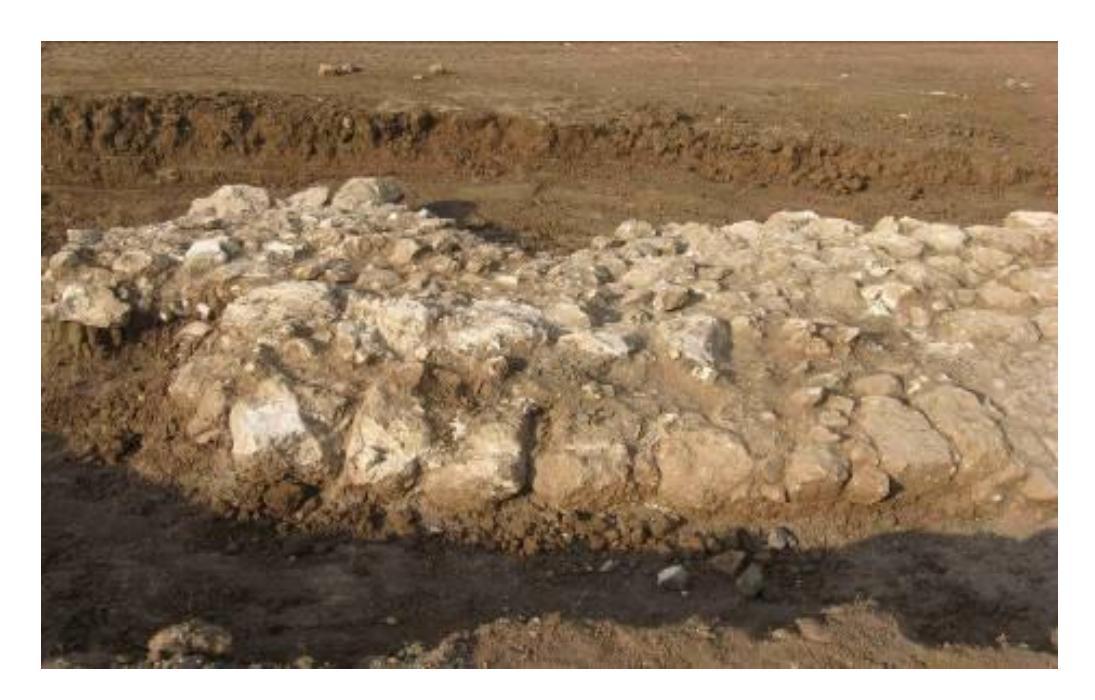
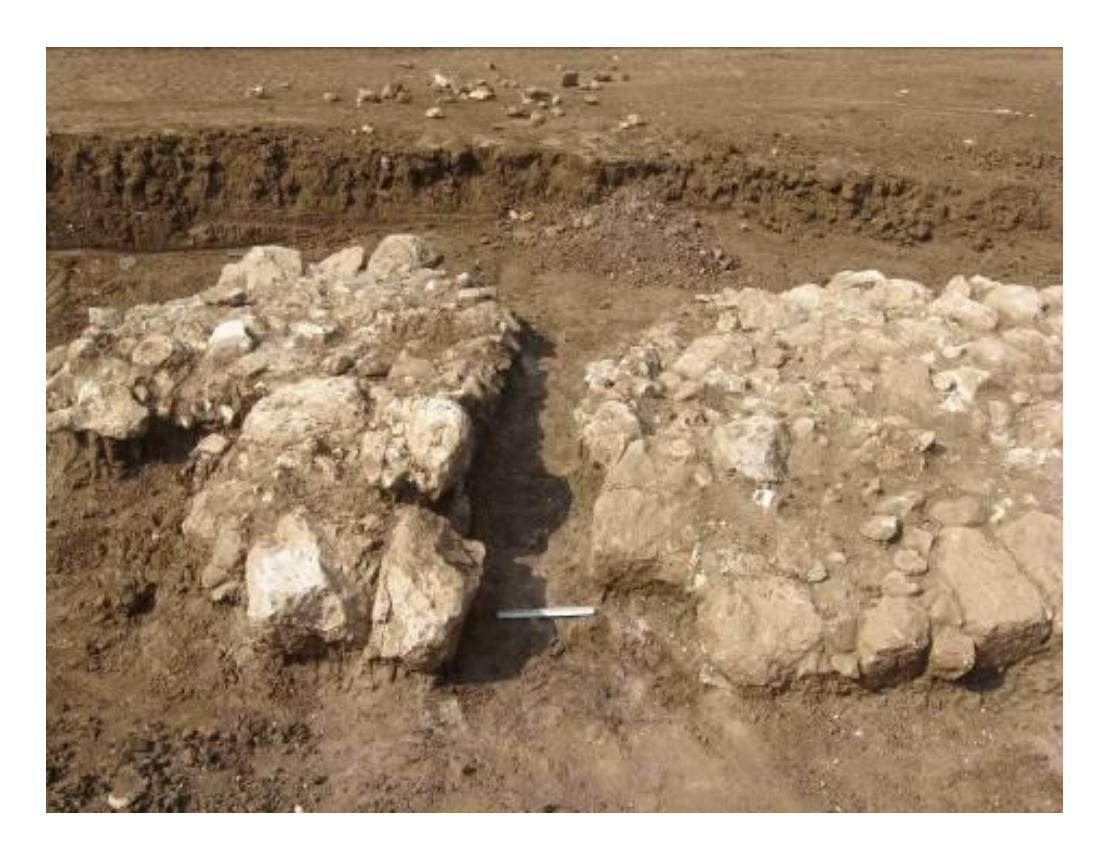
Figure 16: The leveled stone area before digging the section.

Figure 17: The leveled stone area after excavating the section.

In order to create this test section a 50cm-wide area running southwest-northeast through the entire width of the leveled stone area was excavated (Figs.16-17). Here

too, however, no significant evidence was found that might shed further light on the stone area's function. Section 2, however, does support what section 1 indicated – that W005 is set 25cm deeper into the earth than the relatively shallow single course of fieldstones that makes up the leveled stone area.
